2021 Summary Report

Town of Minto

**MINTO PINES SUBDIVISION
DRINKING WATER SYSTEM**

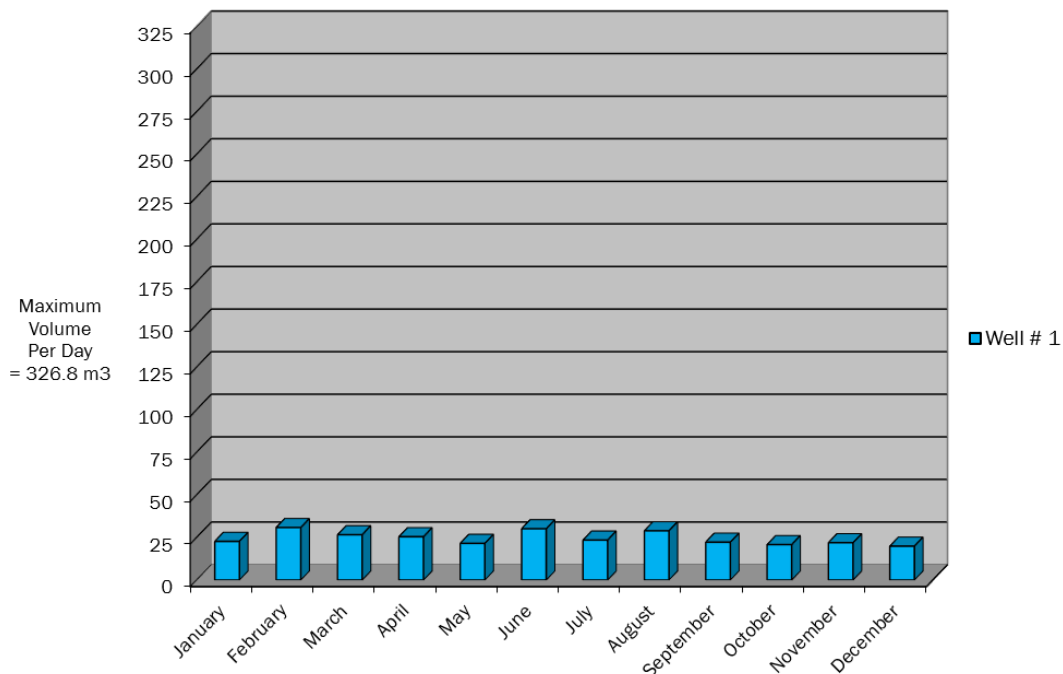
Table 3.3
Maximum Water Usage Per Day by Month

The MDWL stipulates, “The maximum daily volume of treated water that flows from the treatment subsystem to the distribution system shall not exceed the value identified as the rated capacity in Schedule C Table 1.”

Short-term peaks, in excess of permitted values, may occur at pump start up, while doing specific maintenance procedures or during emergency demand situations.

The time and duration of any flow exceedance is recorded for each event along with the reason for the occurrence. There were no extended exceedances or exceedances over the daily permitted rate in the Minto Pines Drinking Water System.
